ÉCOLE DE TECHNOLOGIE SUPÉRIEURE
DÉPARTEMENT DE GÉNIE DE LA CONSTRUCTION
DRSR : **D**ÉVELOPMENT & **R**ÉSEARCH FOR **S**TRUCTURES AND **R**ÉHABILITATION

EXECUTIVE SUMMARY REPORT

FATIGUE TESTING OF GOODCO Z-TECH SINGLE SUPPORT BAR MODULAR BRIDGE EXPANSION JOINT WITH WELDED STIRRUPS

April 2012

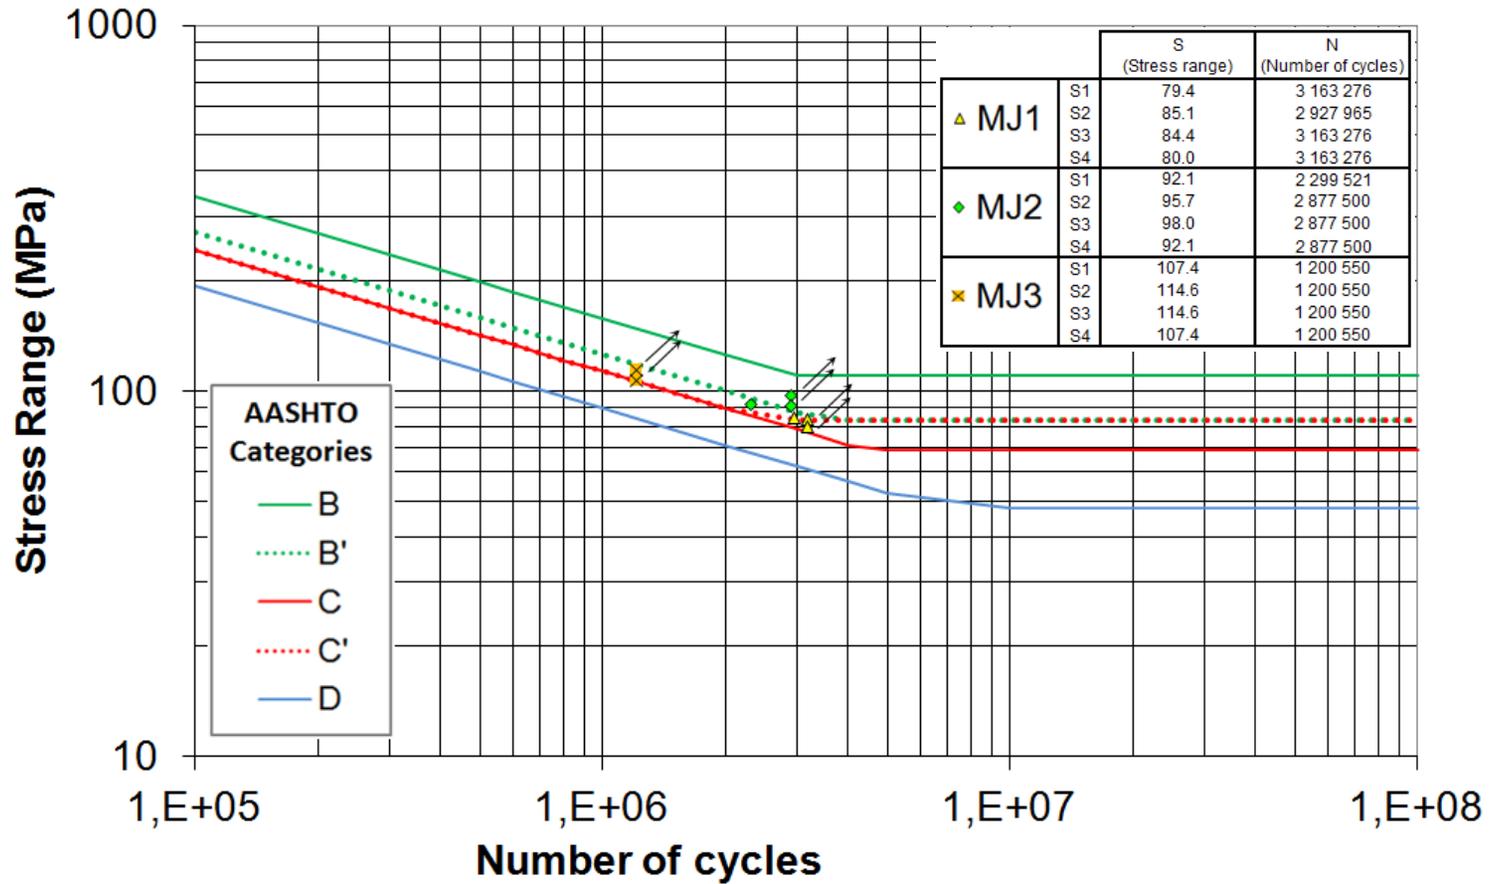
Figure 7 –Twelve S-N Points Obtained for Stirrup Details from Fatigue Tests in Conformity to AASHTO and NCHRP-402

S-N Curves for Stirrups Details

The twelve S-N (Stress range versus Number of cycles) experimental points obtained are drawn in **Figure 7** along with the S-N lower limit curves specified by the AASHTO LRFD 2007 Bridge Design Code for selected fatigue categories, including the targeted category C. As can be seen from these figures, the fatigue resistance of the welded stirrup details of the MBEJ is compatible and meets category C requirements as defined by the AASHTO LRFD 2007 Bridge Design Code.
